2021 Progress Report

An examination and discussion of Woodbridge Township responses to the CVA report's original recommendations

**WOODBIDGE RIVER FLOODPLAIN
POST-RESTORATION MONITORING AND
MAINTENANCE PROGRAM**
Woodbridge Township
Middlesex County, New Jersey

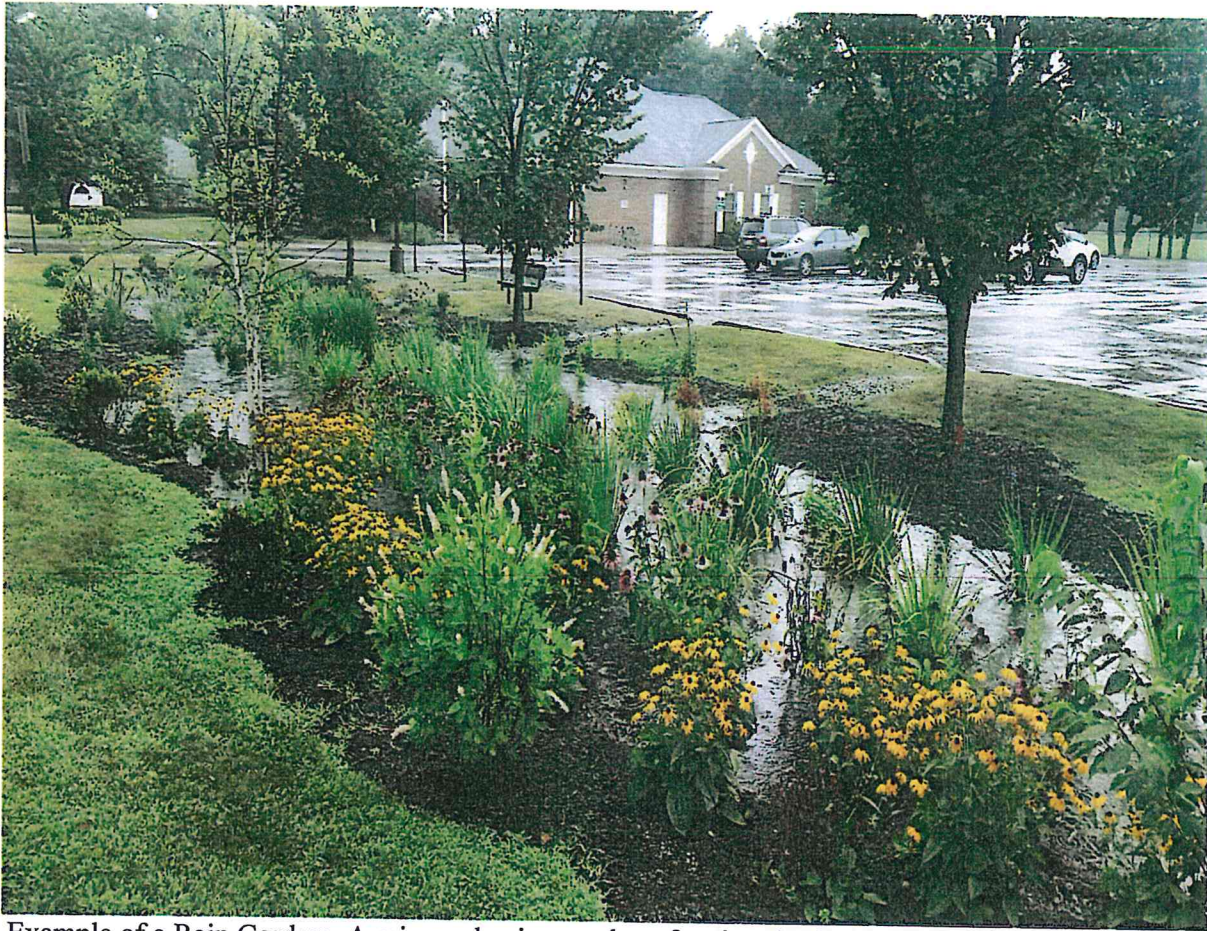
Example of a Rain Garden: A rain garden is a garden of native shrubs, perennials, and flowers planted in a small depression, which is generally formed on a natural slope. It is designed to temporarily hold and soak in rain water runoff that flows from roofs, driveways, patios or lawns.

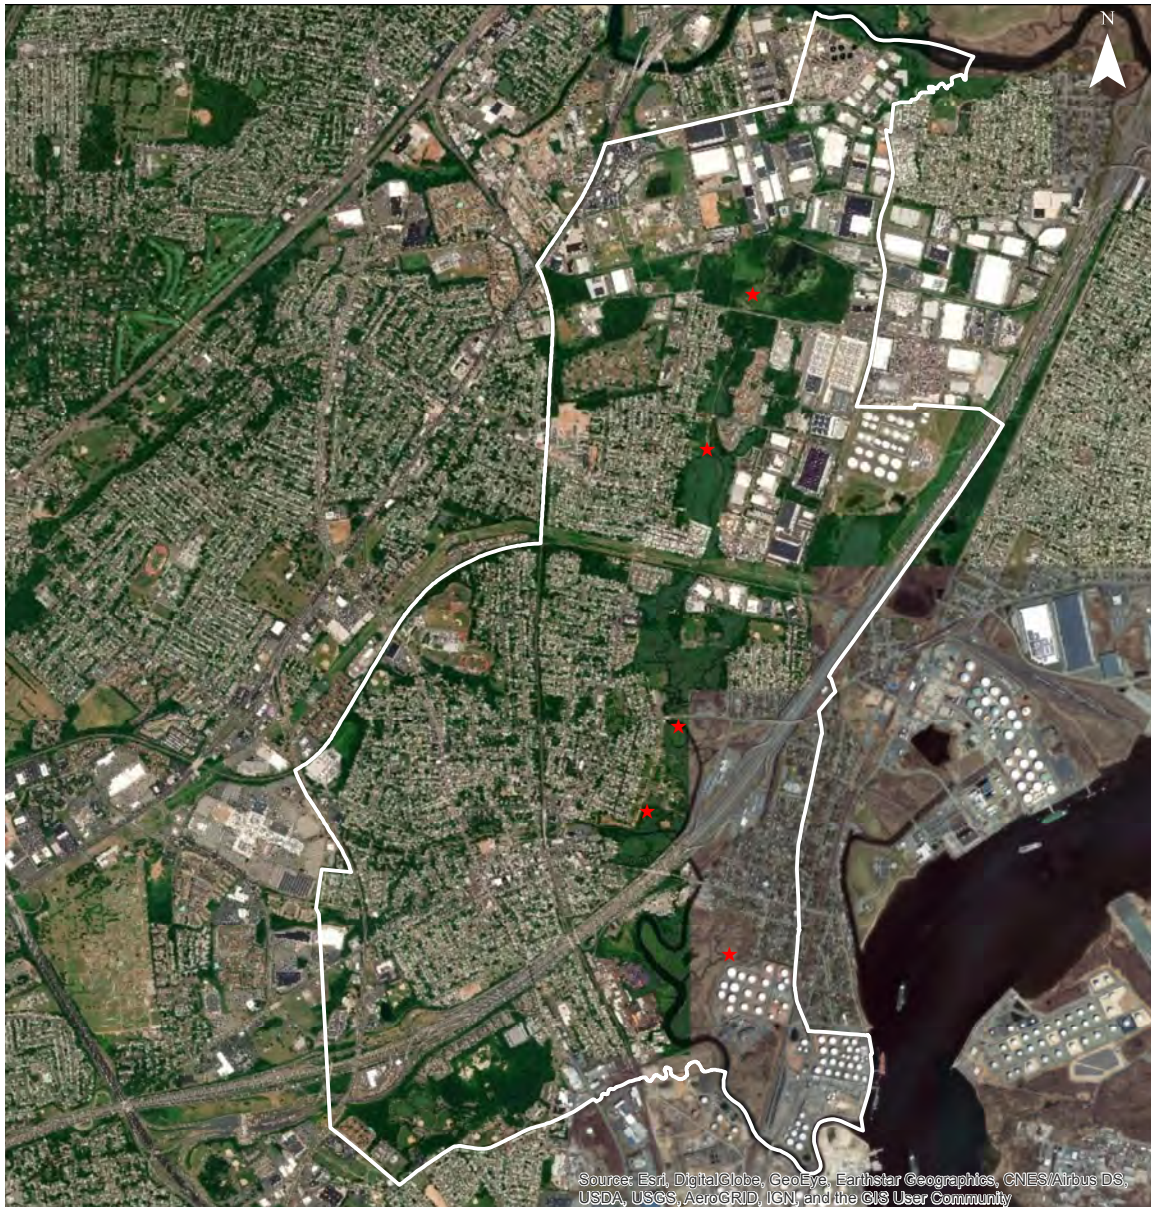
Figure 3: Avian monitoring locations

Point counts are the most widely used quantitative method to monitor bird populations (Ralph et al. 1995). Point counts took place on mornings with fair conditions in the absence of rain or high wind (<10mph). A trained observer arrived at the first point count location within an hour after sunrise and visited points sequentially. Upon arriving at a point, the observer waited for 3 minutes to allow surrounding birds to acclimate and resume normal activity (Rosenstock et al. 2002). After the 3-minute waiting period, the observer started a timer and recorded all birds observed within a 10-minute period, including both the species and the number of individuals (Ralph et al. 1995). If the observer was unsure about the number of individuals present due to potential individual movements between observations, they conservatively recorded the minimum number of individuals likely to have been observed during the 10-minute period.

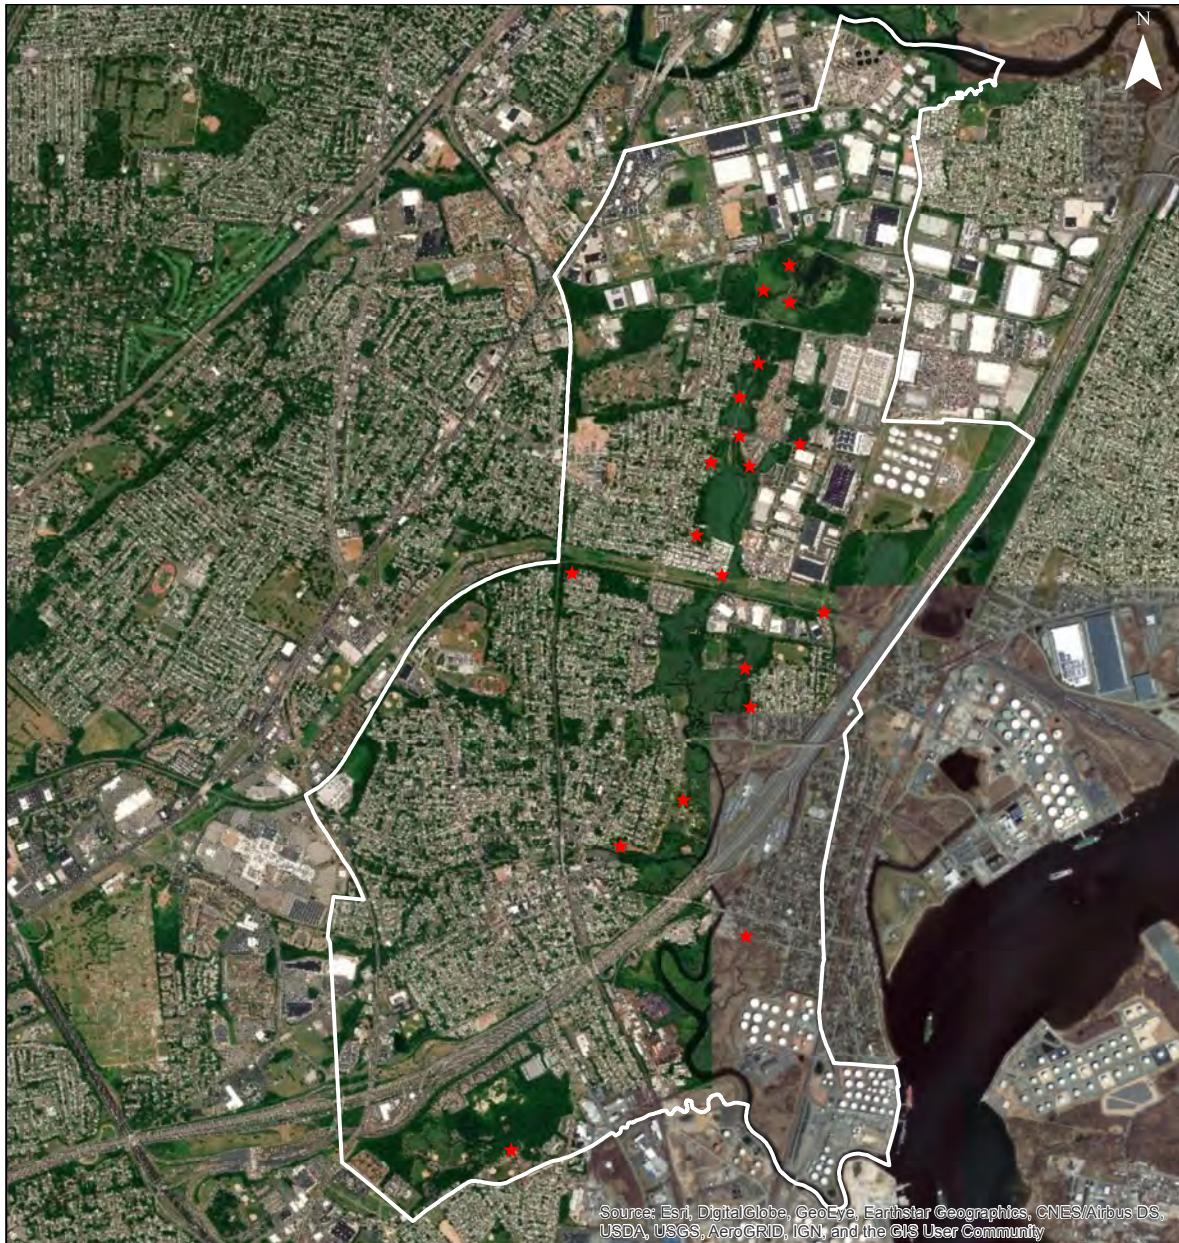
Figure 5: Baseline amphibian survey locations within the Woodbridge River floodplain

RCE performed frog and toad call monitoring at 19 sites along the Woodbridge River floodplain in 2019 to create a baseline species inventory (Figure 5). Frogs and toads can be easily identified by their unique breeding vocalizations. For each survey, RCE spent 3 – 5 minutes at each site and recorded any frog or toad call heard. Surveys occurred bi-weekly on rainy nights from April – June. RCE identified 3 amphibian species utilizing the Woodbridge River, but they only occurred in or near the Ernie Oros Wildlife Preserve and were virtually absent in more developed areas of the Woodbridge River.

To assess the impact of ecological restoration activities on the resident amphibian communities within the project areas, frog and toad call surveys should be conducted at a frequency of once per year. Surveys should occur from April - June, following the protocol used for the baseline monitoring. While there is unlikely to be an increase in species diversity due to surrounding development, RCE expects there to be an increase in abundance of the three resident species, and a further range expansion from the Ernie Oros Wildlife Preserve into nearby connected sites.

Success Criterion: Increase American bullfrog (*Lithobates catesbeianus*), green frog (*Lithobates clamitans*), and northern spring peeper (*Pseudacris crucifer*) presence south of the Ernie Oros Wildlife Preserve to at least three additional survey sites.

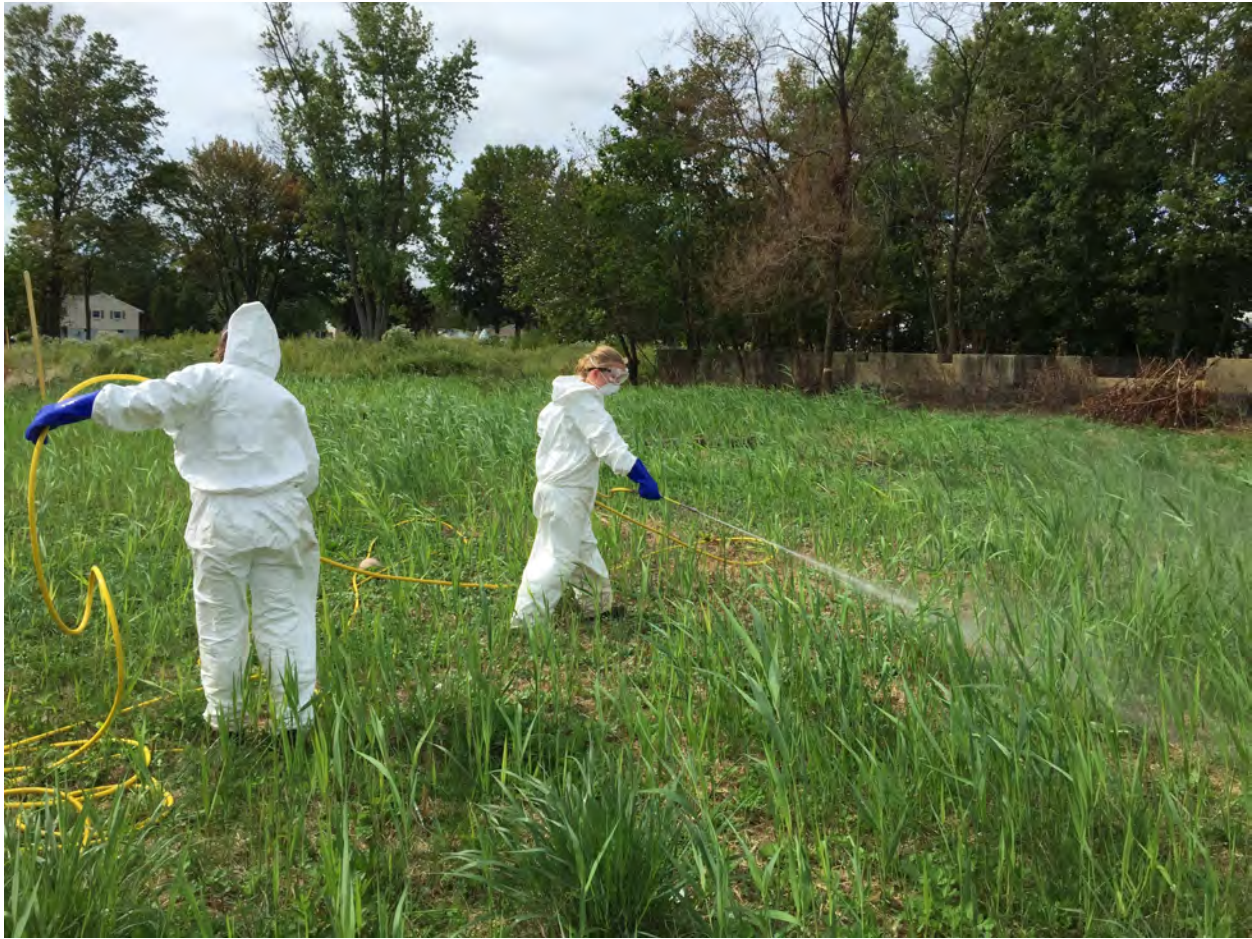
Figure 6: Representative photo of herbicide application to *Phragmites* regrowth in an area that was recently mowed

Species such as Japanese barberry, common privet (*Ligustrum vulgare*), multiflora rose (*Rosa multiflora*), amur honeysuckle, Japanese honeysuckle (*Lonicera japonica*), lilac (*Syringa vulgaris*), and oriental bittersweet (*Celastrus orbiculatus*) should be controlled using the cut-stump method. First, pruning shears, hand saws, or similar tools are used to manually remove aboveground plant material. Immediately after cutting, a concentrated glyphosate solution should be applied to the stumps to prevent regrowth.

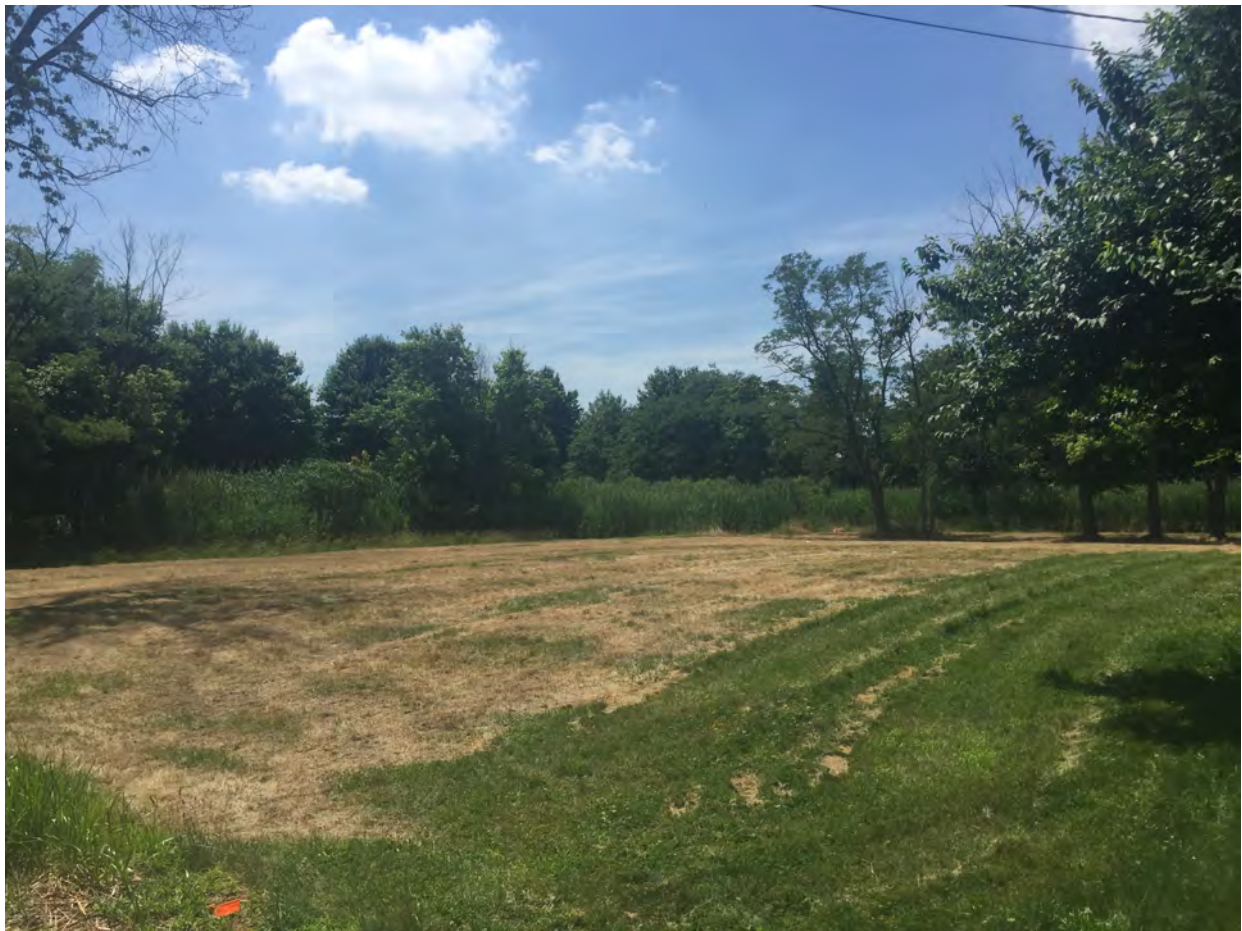
Figure 7: Representative photo of turf grass management in preparation for meadow installation

Prior to meadow establishment, turf grass and all non-native plants must be removed from the site. This can be achieved through 2 – 3 applications of a nonselective systemic herbicide such as glyphosate during the growing season (Figure 7). The first two applications should occur in mid-May and mid-July. If turf grass or other species continues to re-grow, the area can be treated a third time in late August or early September.

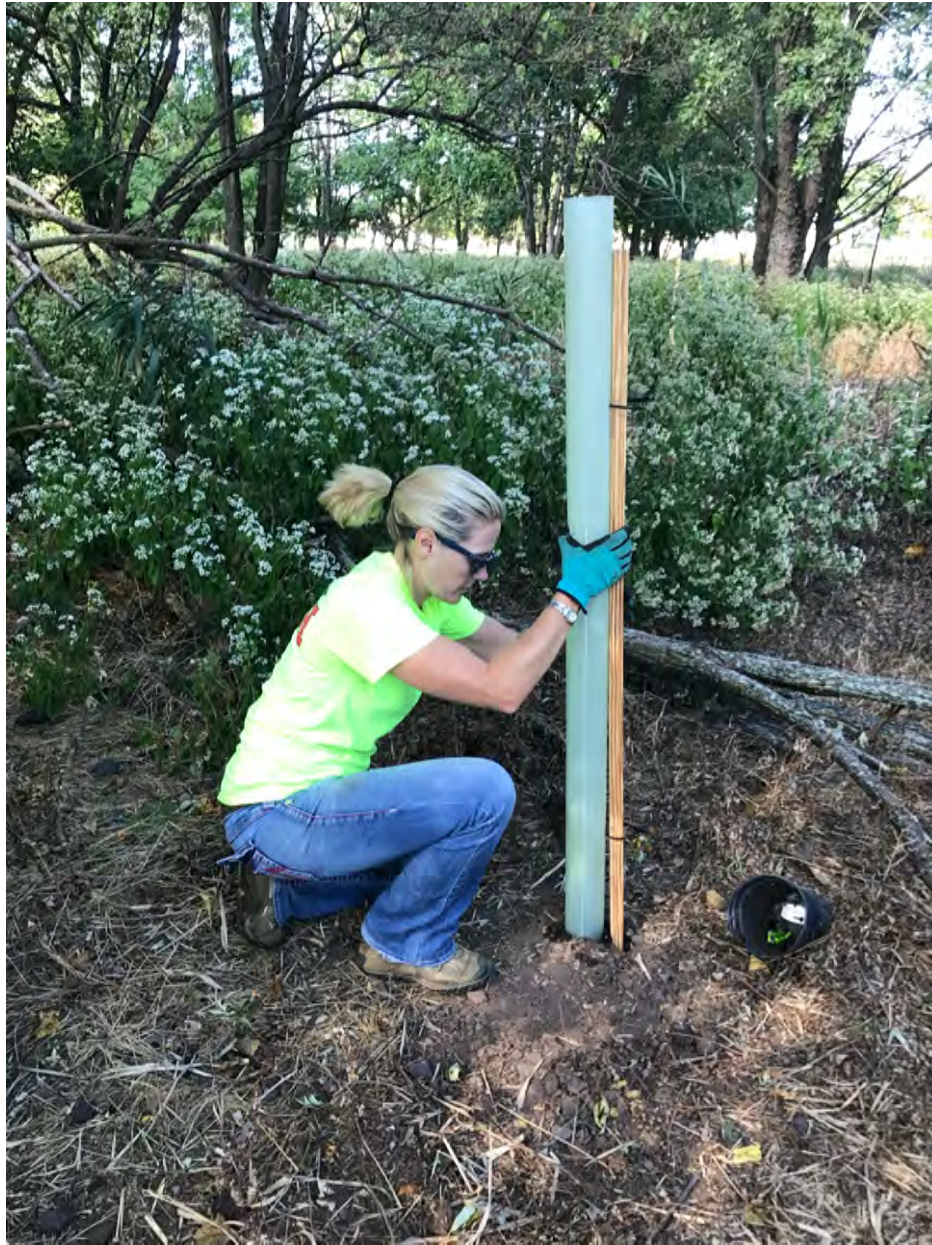
Figure 8: Installation of tree shelter over a native planting

All newly planted trees and shrubs should be protected with 3 to 5-ft tree shelters (i.e. Tubex®) to protect the plantings from herbivory. These hard-plastic cylindrical tubes force saplings to grow above the reach of deer browse, while also protecting them from ground-feeding mammals such as rabbits, mice and voles. In addition to physical protection, the shelters are constructed of translucent, UV-stabilized plastic which creates a greenhouse microclimate of high humidity, reduced air movement, and lower light intensity inside the shelter, ultimately increasing sapling growth rate.

Tube shelters should be inspected at least twice per year (and preferably more) to fix any slanted or tipped over shelters, replace broken or rotten stakes, remove old leaves and debris from the bottom of the shelter, and remove any small mammal nests inside the shelter. Routine maintenance will help the trees stay free of disease and pests.

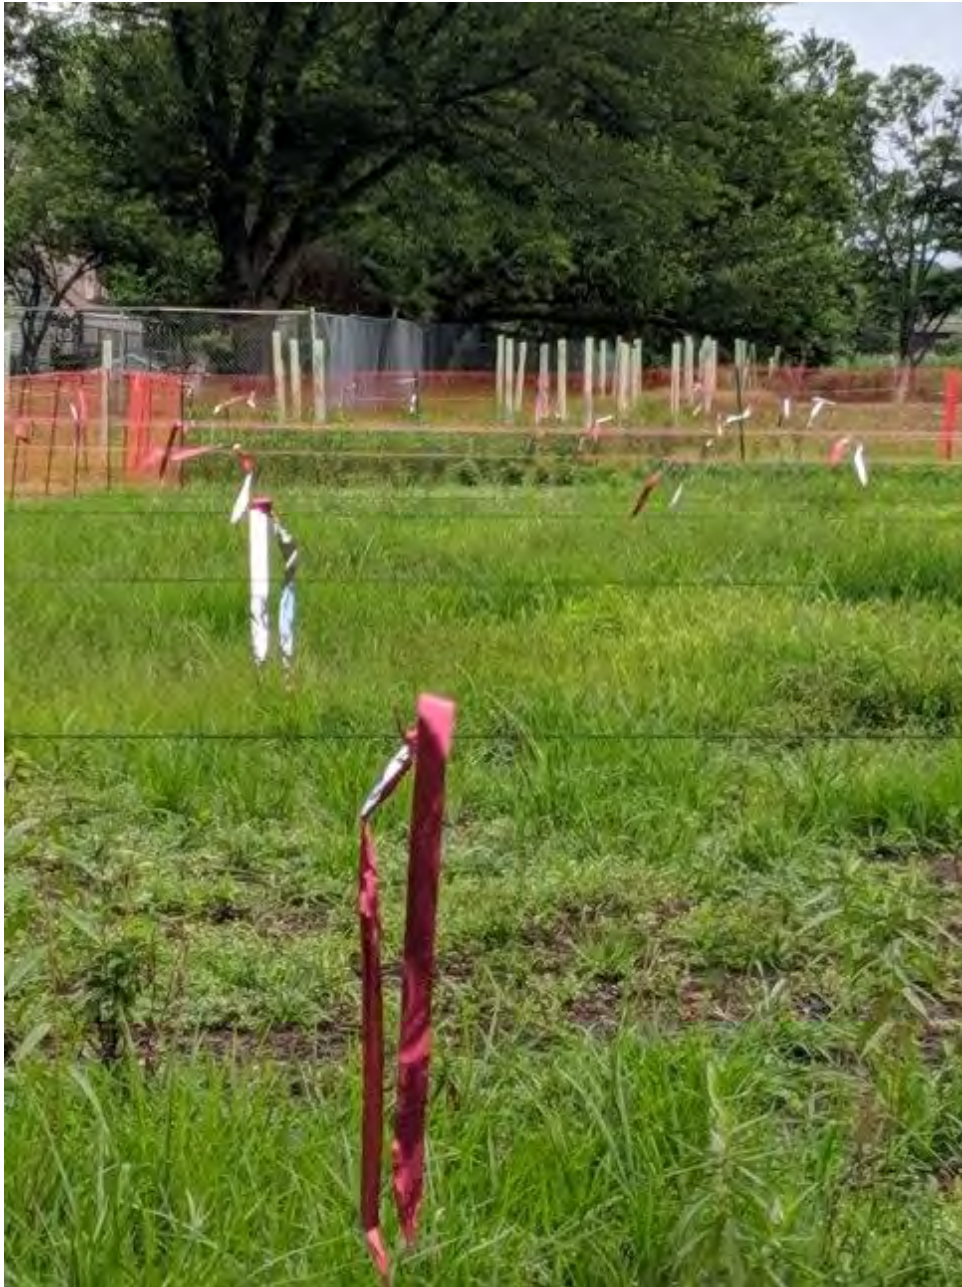
Figure 9: Herbaceous plantings protected with snow fencing, grid wire, and mylar flagging to help deter Canada goose herbivory

Herbaceous wetland plants should be protected from goose damage using typical exclusion practices. Heavy plastic snow fencing supported by 3-5' high sturdy posts should be erected around the perimeter of the planted areas. Overhead grids of monofilament line or Kevlar wire should be constructed above the plantings at a spacing of 2-6 ft. Grids should be adorned with mylar tape (Figure 9).

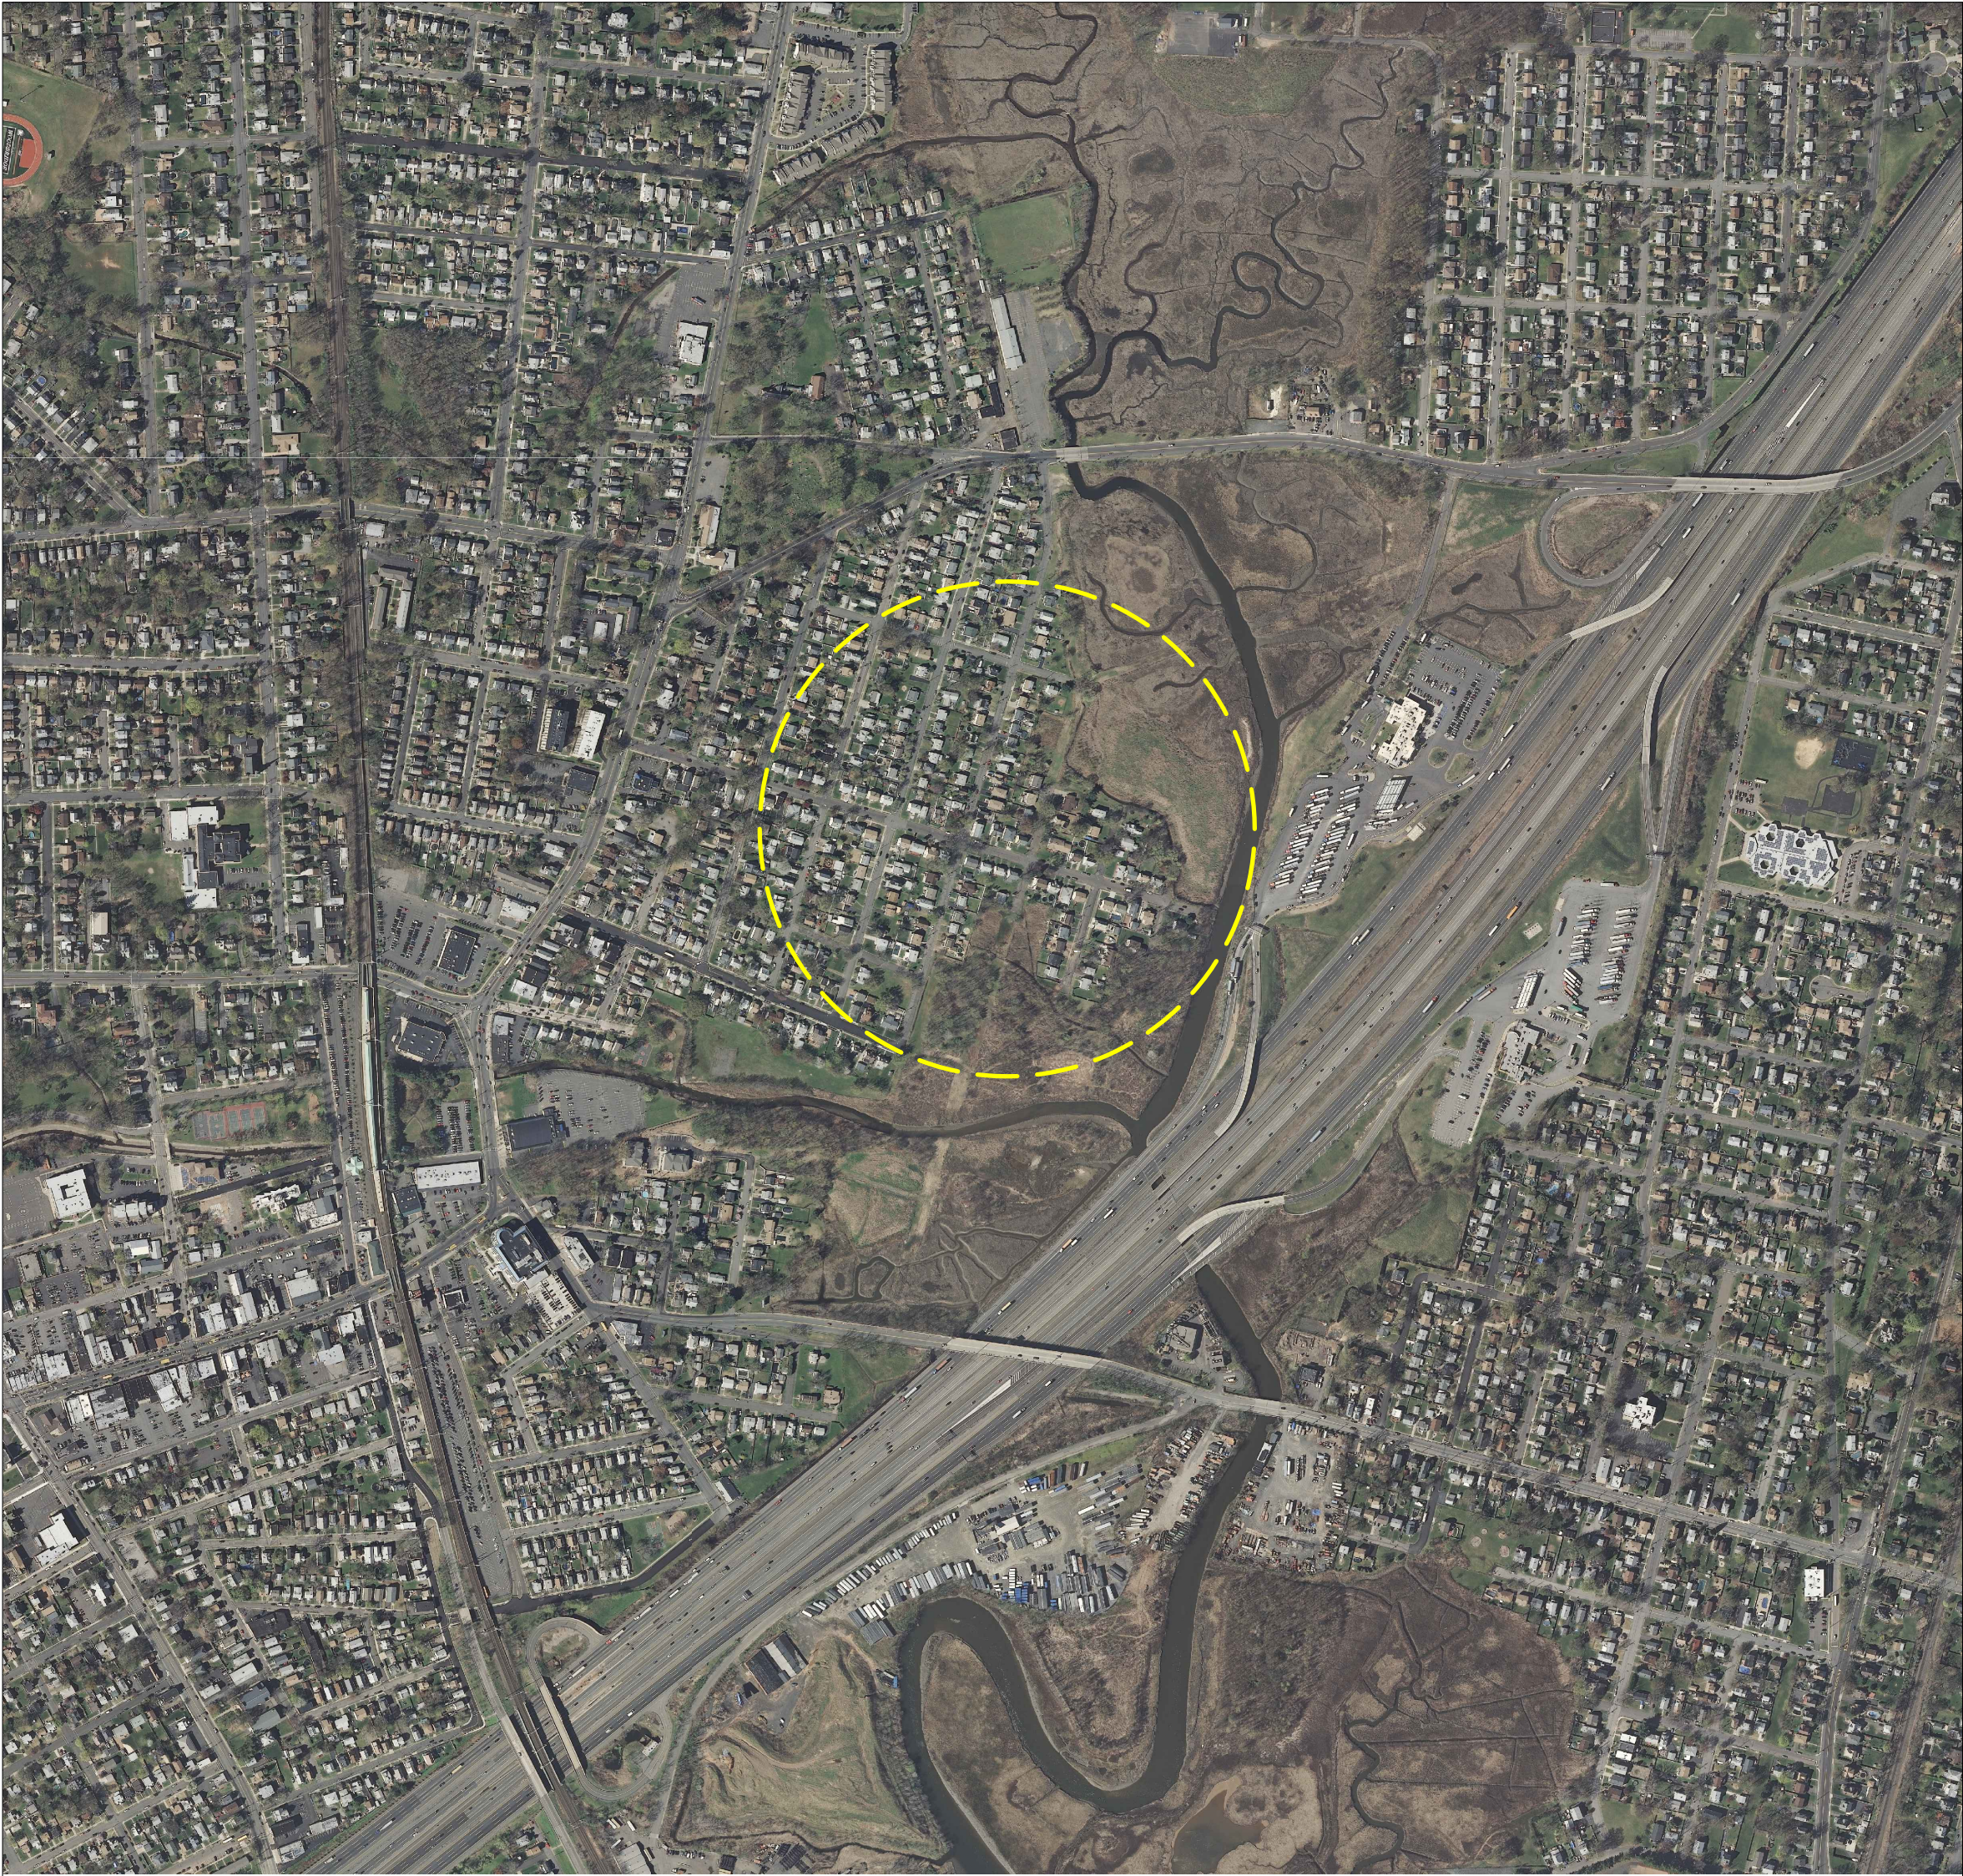
THIS PROJECT PROPOSES CONSTRUCTION OF A WETLAND DESIGNED TO CONVEY STORM WATER FROM ADJACENT DEVELOPED AREA TO THE WOODBRIDGE RIVER. THE WETLAND DESIGN REDIRECTS FLOW FROM THREE EXISTING SWALES THROUGH A SERIES OF VEGETATED DEPRESSIONS AND OPEN POOLS, WHERE WATER WILL BE TEMPORARILY STORED AND FILTERED. THE DESIGN INCREASES THE FLOOD STORAGE POTENTIAL OF THE EXISTING LANDSCAPE USING NATURAL ECOLOGICAL FEATURES AND REESTABLISHES NATIVE WETLAND VEGETATION APPROPRIATE TO THE REGION AND THE EXPECTED SITE CONDITIONS.

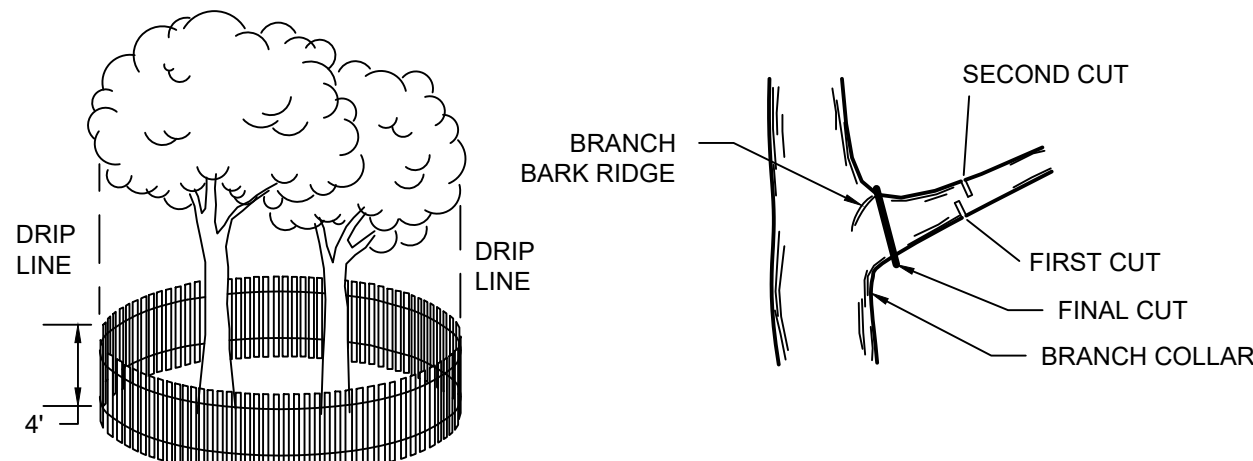
- NOTES:
- TREE PROTECTION SHALL BE PROVIDED FOR ANY AND ALL TREES TO BE PROTECTED DURING AND AFTER CONSTRUCTION.
 - 4 FOOT HIGH SNOW FENCE SHALL BE PLACED AT THE DRIP LINE OF THE TREE AND ENCIRCLE THE ENTIRE TREE.
 - ROOTS SHALL NOT BE CUT IN ANY AREA INSIDE THE DRIP LINE OF THE BRANCHES.
 - TREE LIMB REMOVAL, WHERE NECESSARY, WILL BE DONE FLUSH WITH TRUNK OR MAIN LIMB, GOOD GRADE OF TREE PAINT AND BE PERFORMED UNDER THE SUPERVISION OF A LICENSED NURSERYMAN.

1 TREE PROTECTION AND LIMB REMOVAL
DT-2 N.T.S.

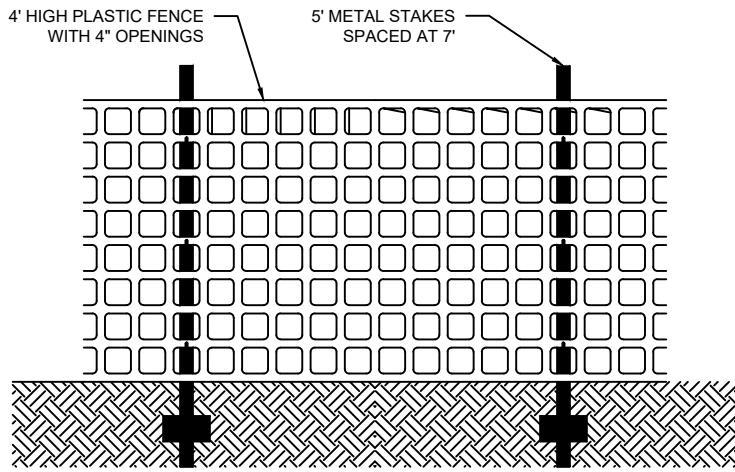
3 ORANGE BARRIER FENCE
DT-2 N.T.S.

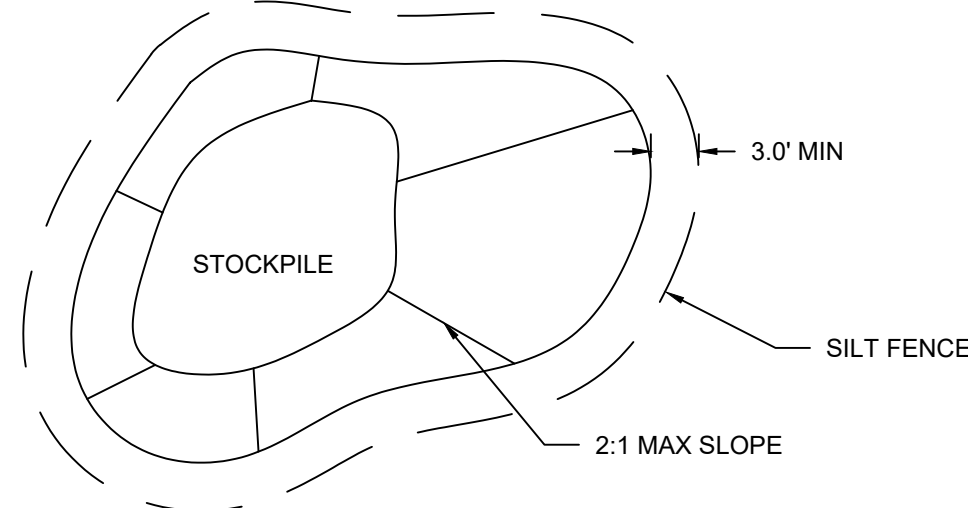
5 STOCKPILING AREA DETAIL
DT-2 N.T.S.

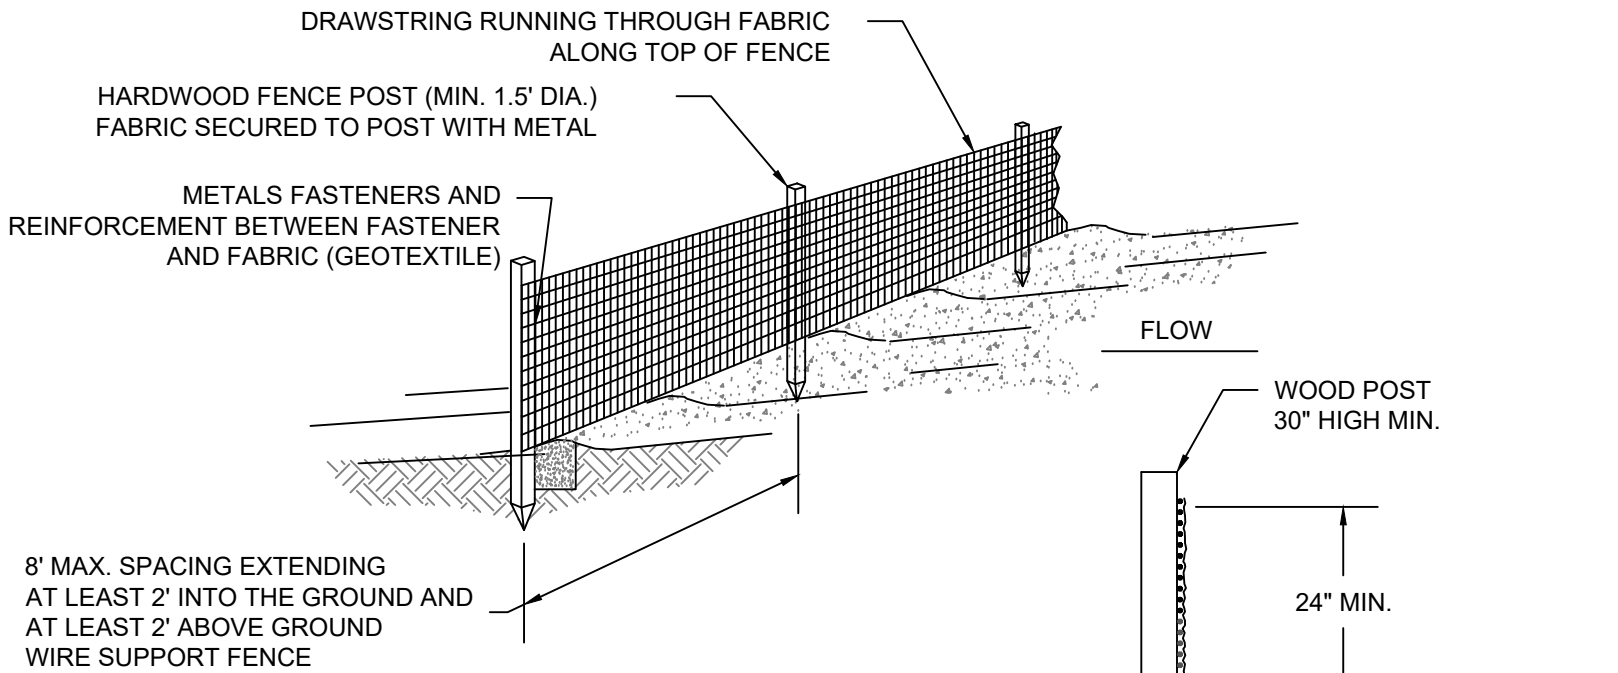
- NOTES:
- SILT FENCE SHALL BE PLACED ALONG SLOPE CONTOURS TO MAXIMIZE PONDING EFFICIENCY.
 - INSPECT AND REPAIR FENCE AFTER EACH STORM EVENT AND REMOVE SEDIMENT WHEN NECESSARY. (9" MAX. RECOMMENDED STORAGE HEIGHT.
 - REMOVED SEDIMENT SHALL BE DEPOSITED TO AN AREA THAT WILL NOT CONTRIBUTE SEDIMENT OFF-SITE AND CAN BE PERMANENTLY STABILIZED.
 - PLACE SILT FENCE AROUND ALL STOCKPILE AREAS AND AROUND STAGING AREAS AS NEEDED AND AT LOCATIONS SHOWN ON THE SOIL EROSION PLAN.
 - THE SLOPE OF THE LAND FOR AT LEAST 30 FEET ADJACENT TO ANY SILT FENCE SHALL NOT EXCEED 5%.
 - SILT FENCE SHALL REMAIN IN PLACE FOR THE DURATION OF THE PROJECT UNLESS OTHERWISE DIRECTED BY ENGINEER.

7 SILT FENCE
DT-2 N.T.S.

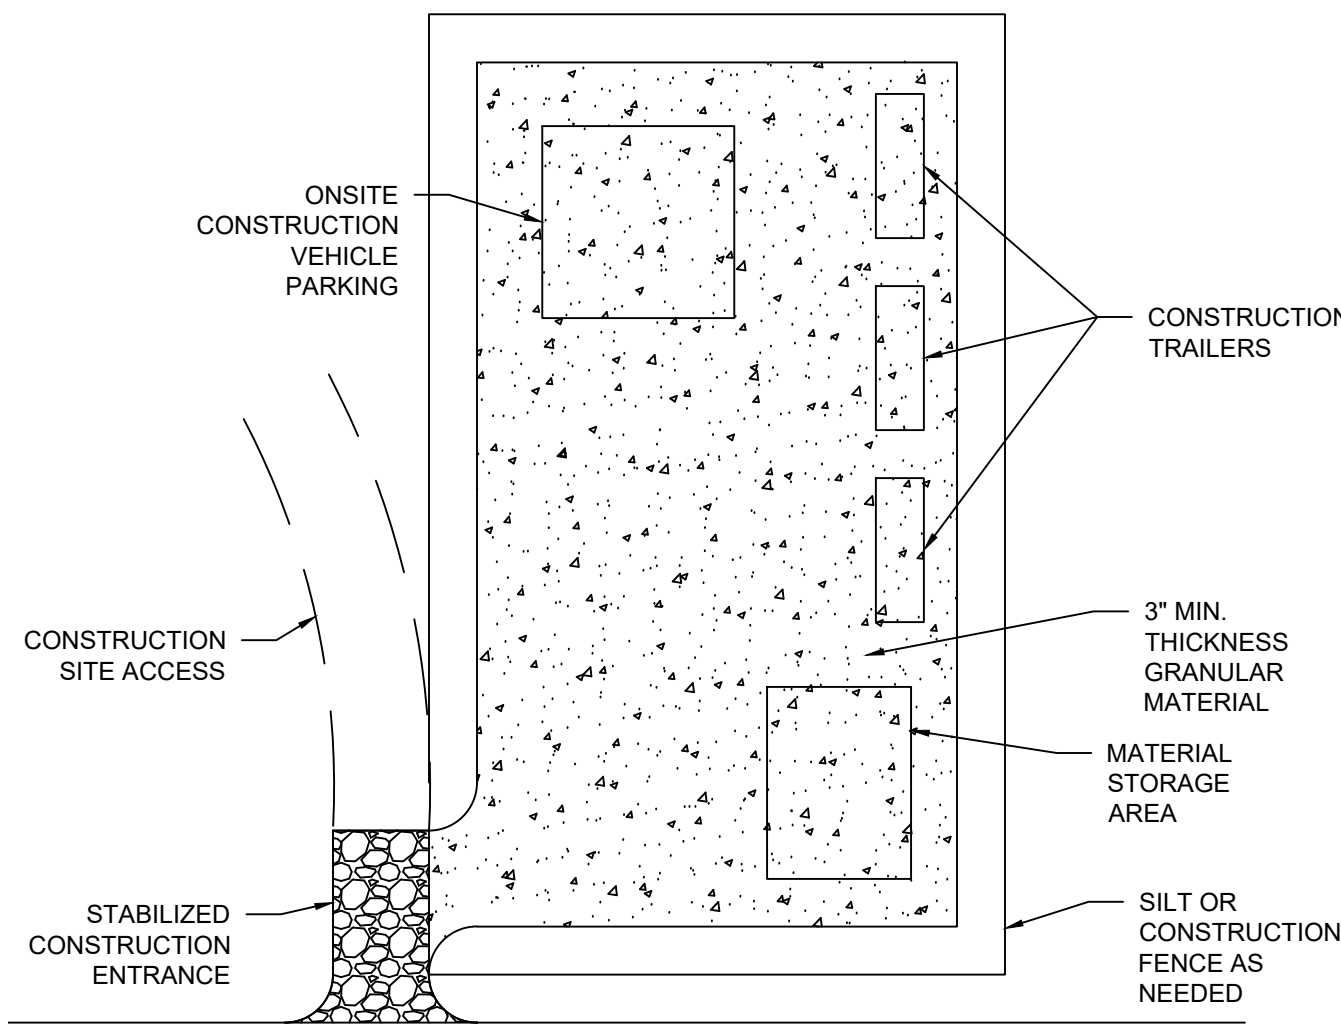
8 STAGING AREA DETAIL
DT-2 N.T.S.

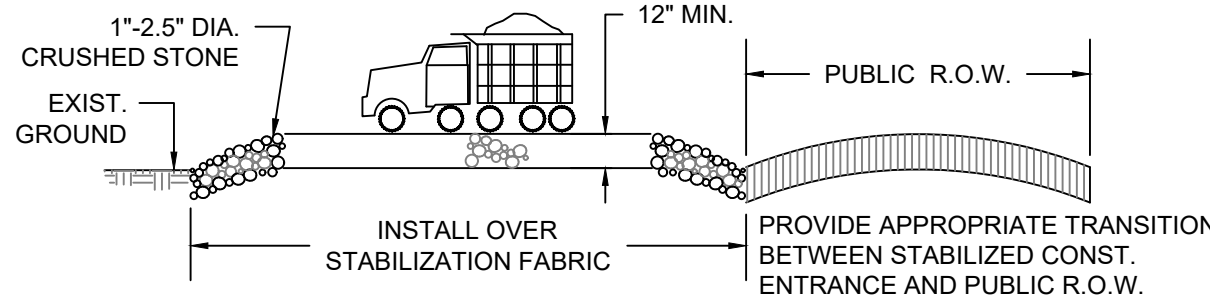
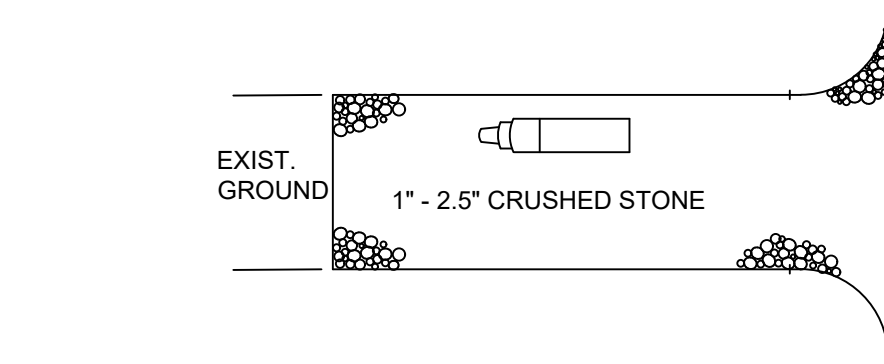
2 CONSTRUCTION ENTRANCE
DT-2 N.T.S.

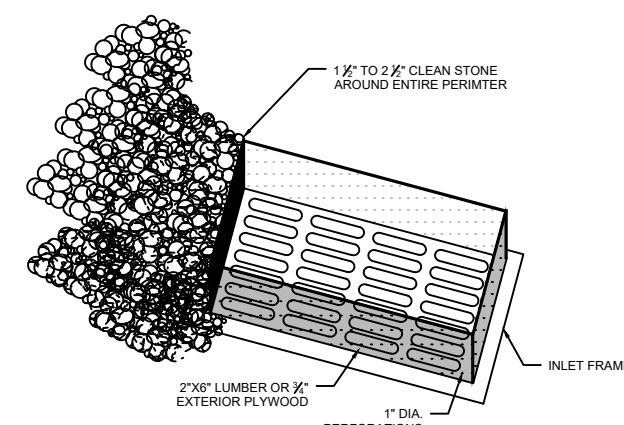
4 INLET PROTECTION
DT-2 N.T.S.

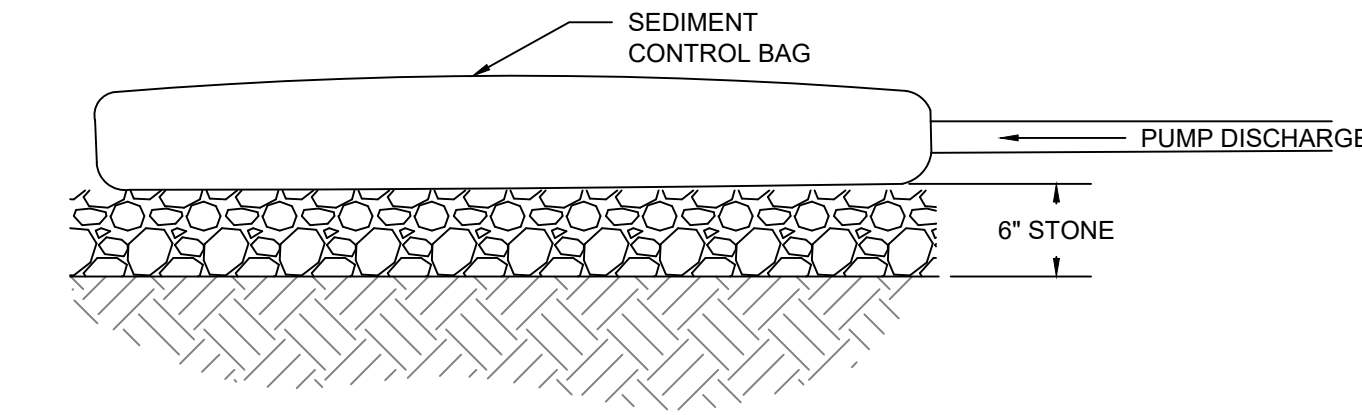
6 DEWATERING ELEVATION DETAIL
DT-2 N.T.S.

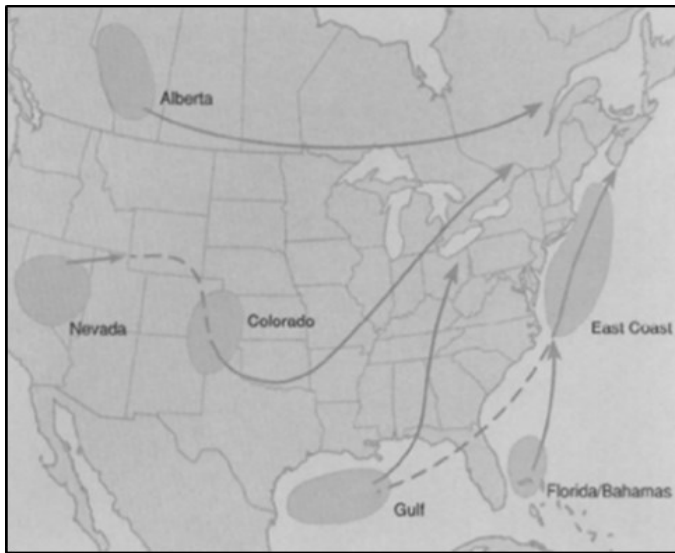
Figure 4: Typical paths of nor'easter

Flood damages in Woodbridge Township are caused by tidal and fluvial flooding. Tidal flooding is caused by coastal storms, which consist of two general types: (1) tropical storms and hurricanes; and (2) extra-tropical storms or nor'easters. The former consist of warm-core, cyclonic systems generated in the tropics. These systems derive their energy from oceanic heat and evaporation. Nor'easters are cold core, cyclonic systems that usually form in areas where strong surface temperature gradients coincide with a strong jet stream aloft (Figure 4). Intense winds generated by both of these storms tend to pile water against the coast-line, and raise tide levels above normal to create a "storm surge." Other factors contributing to storm surge include falling atmospheric pressure levels, mildly sloping coasts and "setup" due to breaking waves.

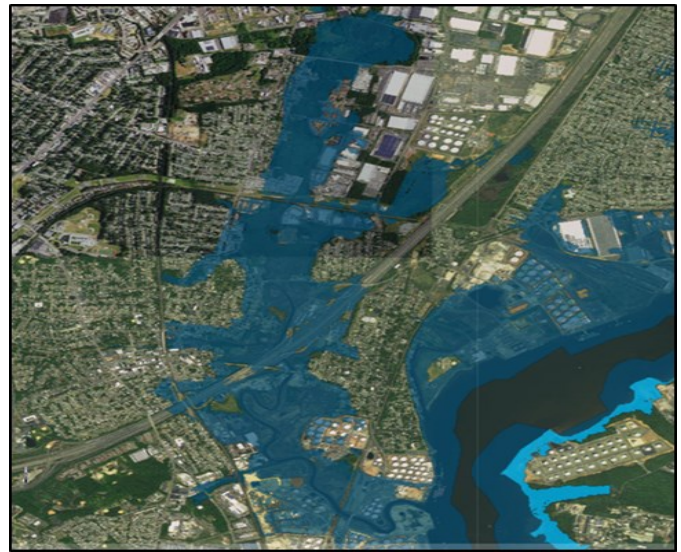
Figure 5: Approximate area of inundation in Woodbridge during Super Storm Sandy (Source: USGS Sandy Storm Sandy Tide Mapper)

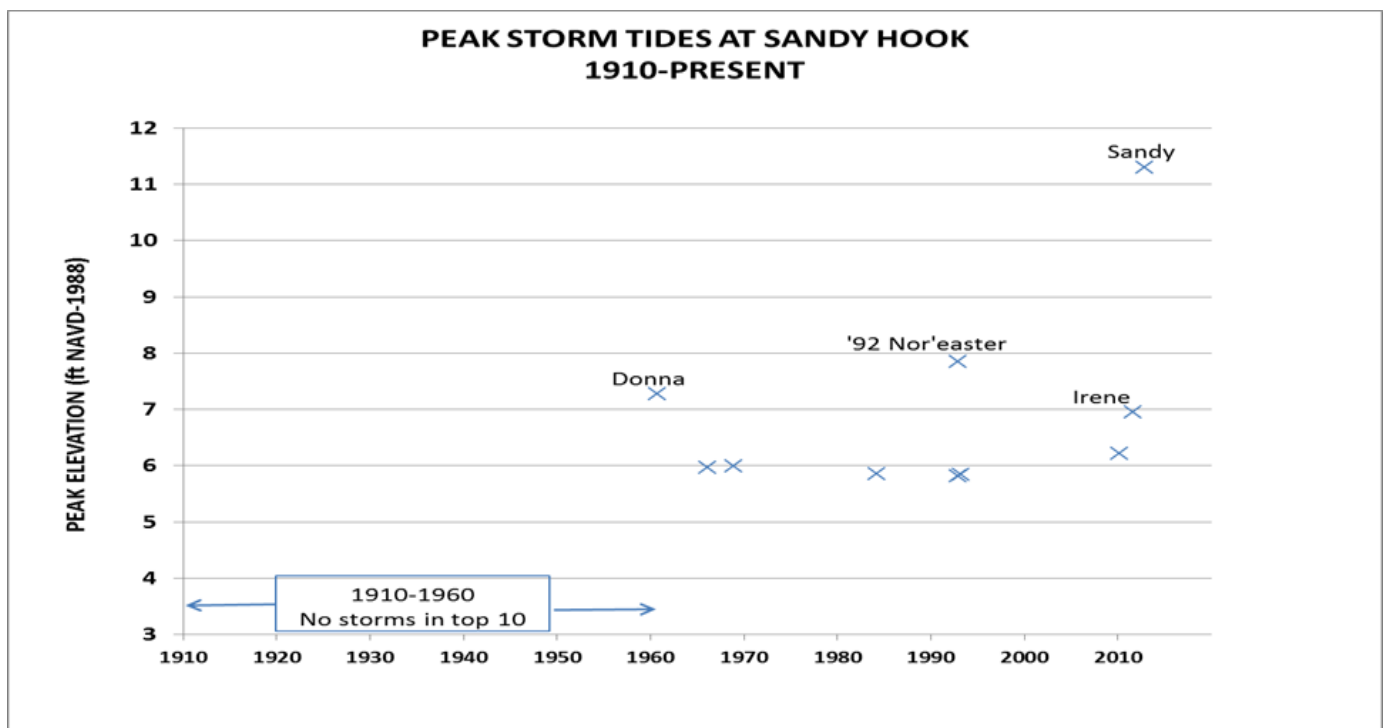
Figure 6: Top ten peak storm tide elevations at Sandy Hook, NJ (Data Source: NOAA CO-OPS). Peak storm tide at Sandy Hook is estimated. The highest tidal elevation recorded by NOAA at Sandy Hook during Super Storm Sandy was actually 10.4 feet NAVD88, when the tide gage stopped recording shortly before the peak tide occurred. NOAA estimates that that actual peak tide during Sandy was around 11.3 feet NAVD88, based on USGS HWMs for Sandy Hook sites NJMON07327 and NJMID072.
