2021 Progress Report

An examination and discussion of Woodbridge Township responses to the CVA report's original recommendations

**WOODBIDGE RIVER FLOODPLAIN
POST-RESTORATION MONITORING AND
MAINTENANCE PROGRAM**
Woodbridge Township
Middlesex County, New Jersey

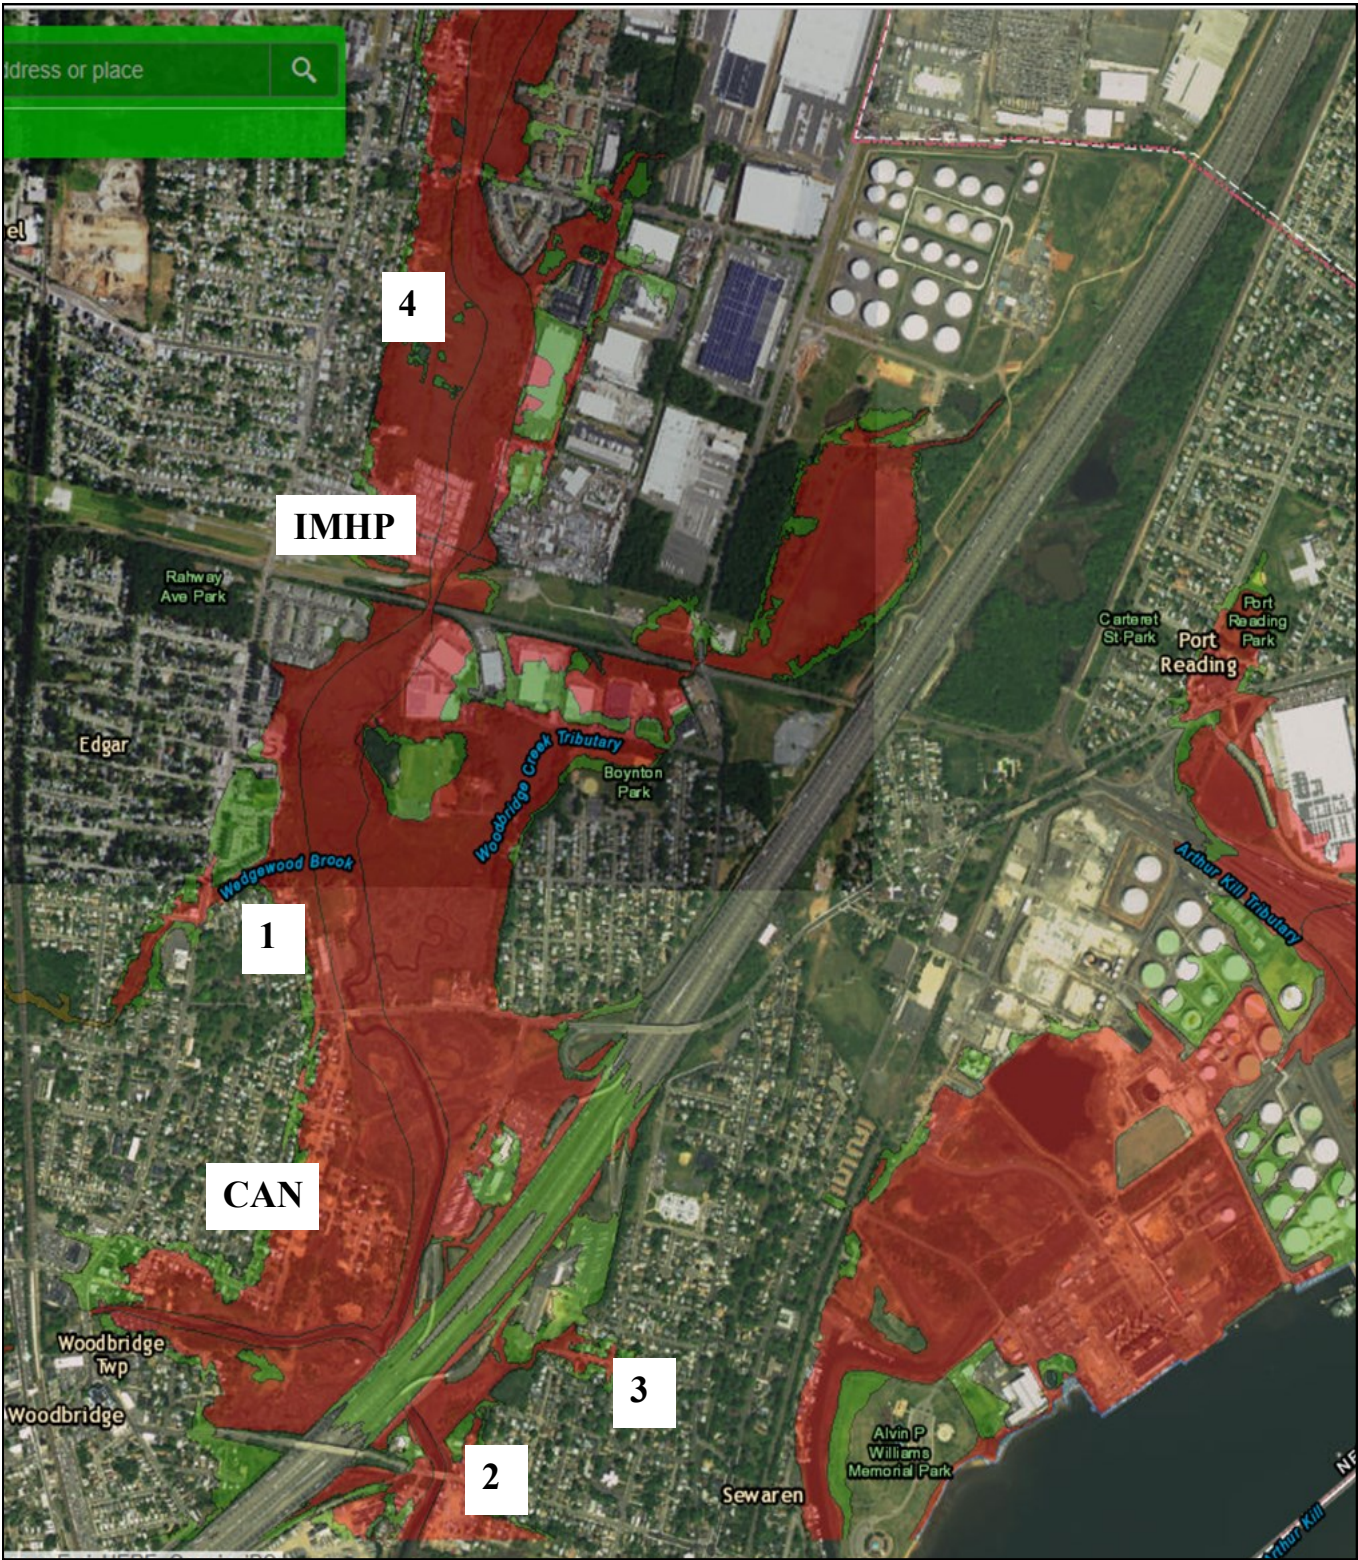
Figure 11: Location of neighborhoods vulnerable to tidal flooding (adopted 2010 FIRM SFHA below 9 feet NAVD88, as displayed on Woodbridge Township GIS)

Besides the CAN and IMHP, there are several other low-lying developed areas near the Woodbridge River/marshes that are susceptible to tidal flooding. As identified in Figure 11, these other areas include: (1) the Wedgewood Avenue neighborhood along Wedgewood Brook; (2) the Austin Street, South Roberts Street and Seawaren Avenue neighborhoods on the south side of the NJ Turnpike crossing (Figure 13); (3) the Vernon Street and Seawaren Avenue neighborhoods, also on the south side of the NJ Turnpike; (4) the upper Woodbridge River tidal floodplain along Blanford Avenue, Borman Avenue and Edgarton Boulevard in the Avenel section; and (5) the Fourth Street neighborhood in the Port Reading Section. Like the CAN, many structures are also being acquired and demolished in each of these areas as a result of the ongoing Blue Acres Buyout Program. The buyouts in neighborhood (1) along Wedgewood Avenue are displayed in Figure 10, while the buyouts in neighborhoods (2), (3), (4) and (5) are illustrated in Figures 12-17, respectively.

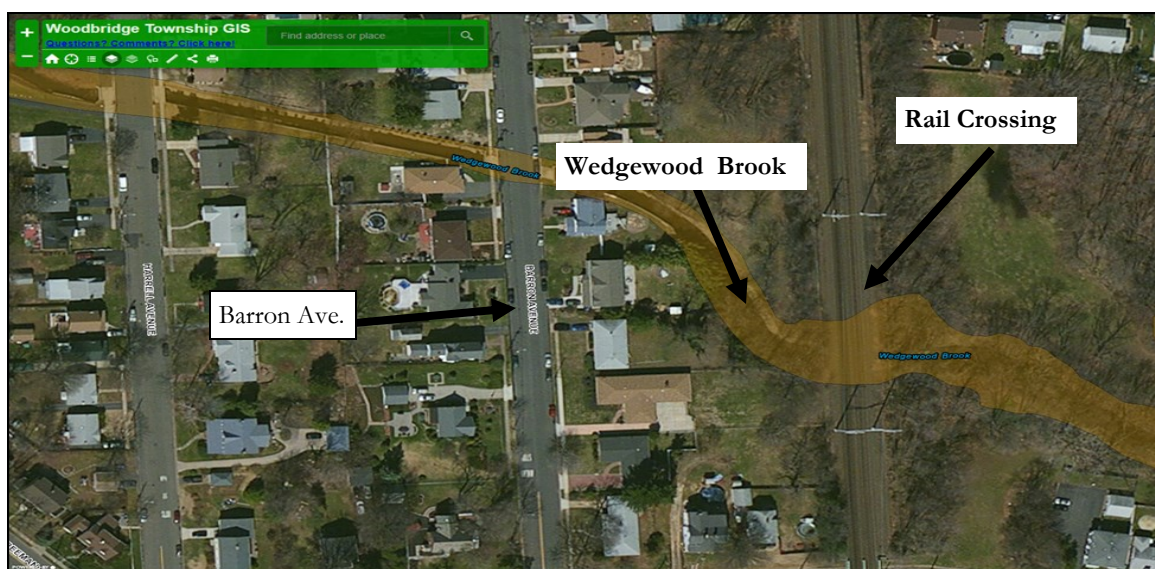
Figure 20: Neighborhood vulnerable to fluvial flooding along Wedgewood Brook near railroad crossing (2010 FIRM SFHA, as displayed on Woodbridge Township GIS)

The low point in Barron Avenue (Figure 20), at the Wedgewood Brook crossing, has an elevation of approximately 16.6 feet. Upstream of the Barron Avenue crossing is Harrell Avenue, which has a low point of approximately 19.6 feet. Model analyses (Najarian Associates, 2013) indicate that the 100-year storm has potential to flood the area to a depth of over 9 feet. Structures as far upstream as Greco Lane also have the potential to be flooded during a major storm event. Approximately 42 residential structures could be affected by the 100-year storm event. The Najarian Associates analysis also revealed that the railroad culverts downstream of the Barron Avenue neighborhood provide a major backwater effect to areas upstream. Since the Railroad Bridge is acting as a berm and creating storage in the floodplain upstream, any increase in the rate of flow through the railroad culvert would, unfortunately, increase flood elevations downstream of the railroad crossing.
